ROCKFORD MUNICIPAL AIRPORT

This report describes how your pavement maintenance management program was developed. This program was developed as part of the Network Pavement Management Program project sponsored by the Idaho Transportation Department, Division of Aeronautics. The information and data contained in this report ensures you are in compliance with the requirements of Federal Aviation Administration (FAA) Grant Assurance Number 11 which states that any airport requesting federal funds for pavement improvement projects must have implemented a pavement maintenance management program (PMMP).

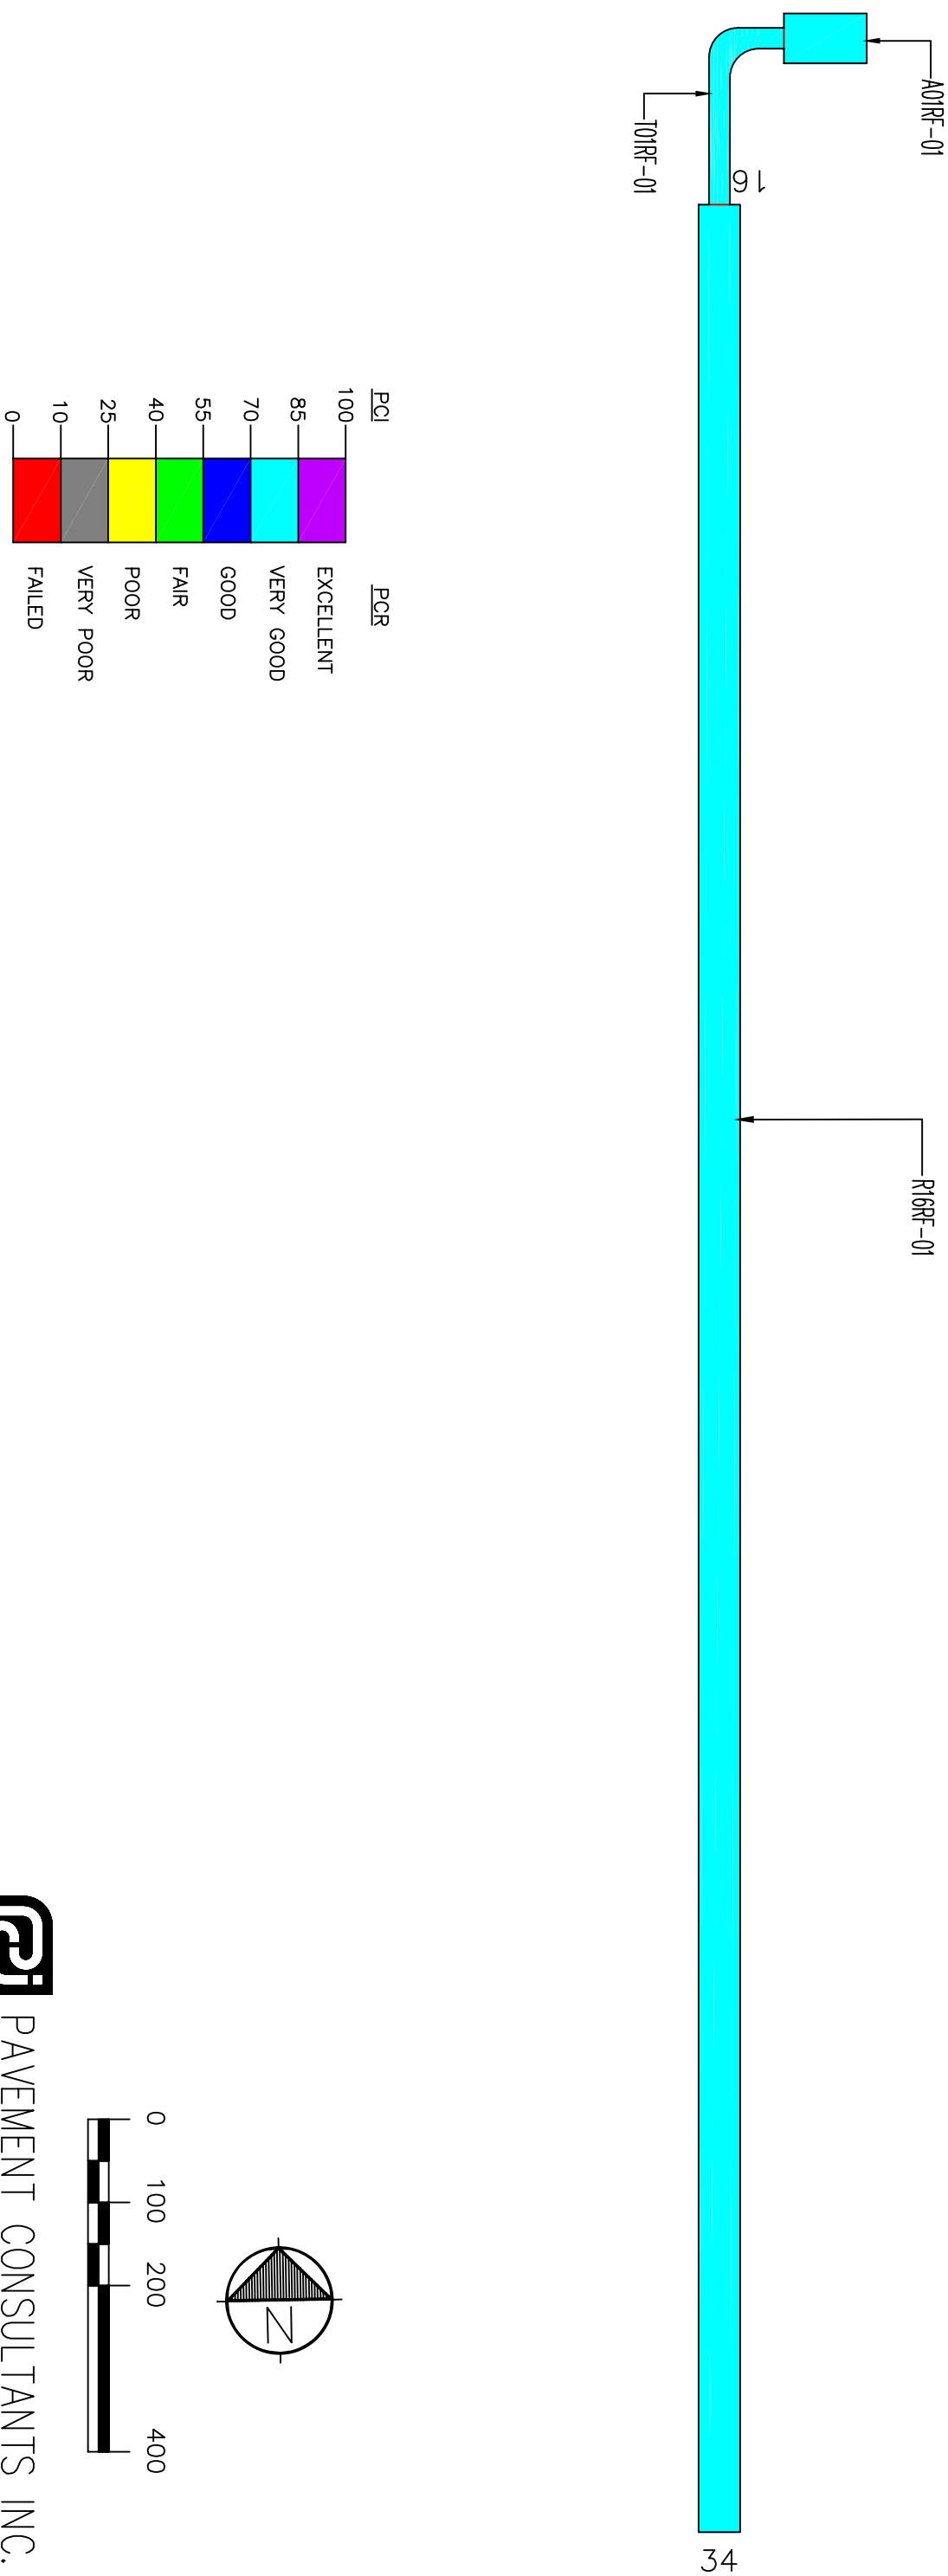
Figure RF-3. Pavement Condition in 2006.
Rockford Municipal Airport

Section PCIs at the airport range from a low of 80 (a PCR of “Very Good”) to a high of 80 (a PCR of “Very Good”). The area-weighted average PCI for all airport pavements is 80 corresponding to an overall PCR of “Very Good”. Figure RF-4 shows how much pavement area is associated with each Pavement Condition Rating category and also shows pavement condition distribution for the inspection conducted in 2006. A graphical representation of the projected PCRs presented in Table RF-2 is shown in Figure RF-5.

The primary distress observed during the inspection was weathering/raveling.

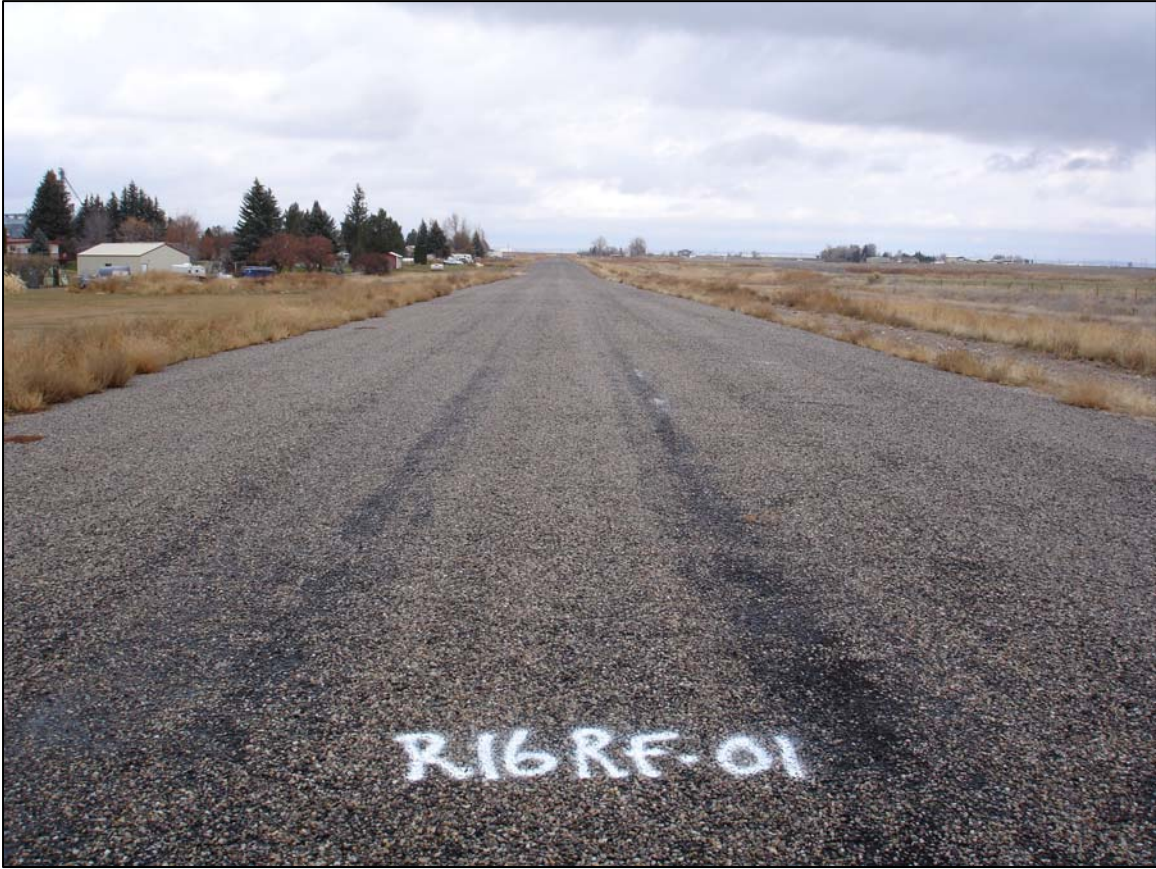
Sample Number:	01	Type:	R	Area:	5,000.00SqFt	PCI = 80
52	WEATHERING/RAVELING			L	2,499.98 SqFt	
Sample Number:	06	Type:	R	Area:	5,000.00SqFt	PCI = 80
52	WEATHERING/RAVELING			L	2,499.98 SqFt	
Sample Number:	12	Type:	R	Area:	5,000.00SqFt	PCI = 80
52	WEATHERING/RAVELING			L	2,499.98 SqFt	
Sample Number:	18	Type:	R	Area:	5,000.00SqFt	PCI = 80
52	WEATHERING/RAVELING			L	2,499.98 SqFt	
Sample Number:	24	Type:	R	Area:	5,000.00SqFt	PCI = 80
52	WEATHERING/RAVELING			L	2,499.98 SqFt

Section: R16RF-01
Weathering/ Raveling

Network	Branch	Section	Distress	Severity	Distress Quantity	Units	Action	Maint. Quantity	Units	Unit Cost	Total Cost
ROCKFORD	A01RF	1	WEATH/RAVEL	L	3,000.00	SQFT	No Localized M & R	3,000.00	SqFt	\$0.00	\$0.00
Total											\$0.00
ROCKFORD	R16RF	1	WEATH/RAVEL	L	70,000.00	SQFT	No Localized M & R	69,999.40	SqFt	\$0.00	\$0.00
										Total	\$0.00
ROCKFORD	T01RF	1	WEATH/RAVEL	L	3,468.00	SQFT	No Localized M & R	3,468.00	SqFt	\$0.00	\$0.00
Total											\$0.00
TOTAL											\$0.00
